**Field of expertise:** Offshore engineering, special equipment

**Client:** DCN International Diving and Marine Contractors

## Design diving habitat for a gas pipeline reparation in the Java Sea

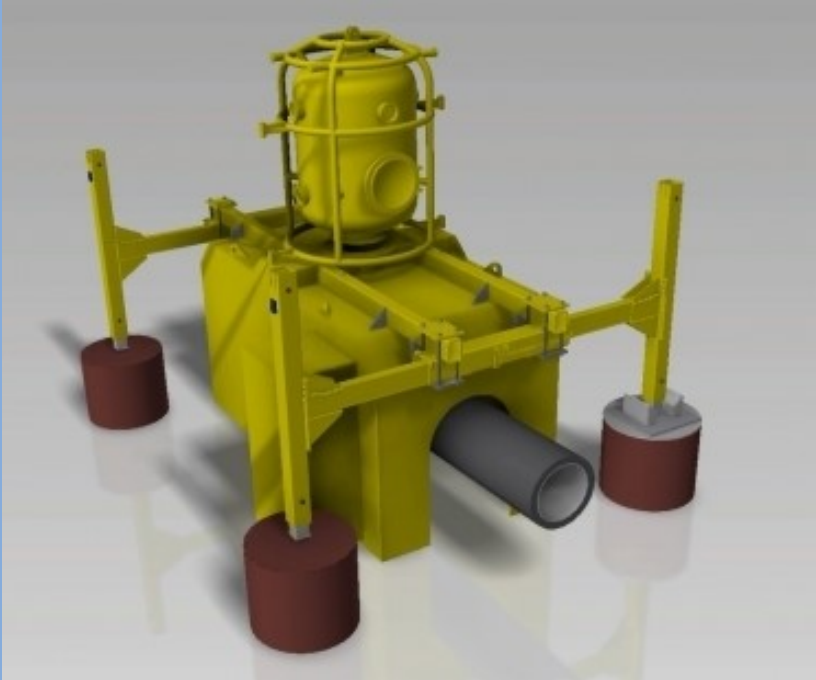
The repair procedure had to be executed under water in dry conditions. Therefore a special diving habitat was needed to let divers repair the pipe in dry and safe working conditions.

- ◆ Developing an underwater positioning system for the diving habitat. The habitat is designed with retractable hydraulic legs that are adjustable in all directions. This complex design was necessary to position the habitat over the pipeline and lower it without transferring any forces onto the pipe.
- ◆ Design of suction piles to provide a safe foundation for the habitat.
- ◆ Establishing design conditions for waves and currents.
